Manhole Inspection Summary

Manhole # S27C__023MH

Insp Date: **12/10/07 1:24 PM**

Location Address: **900 FRANKLIN ST**

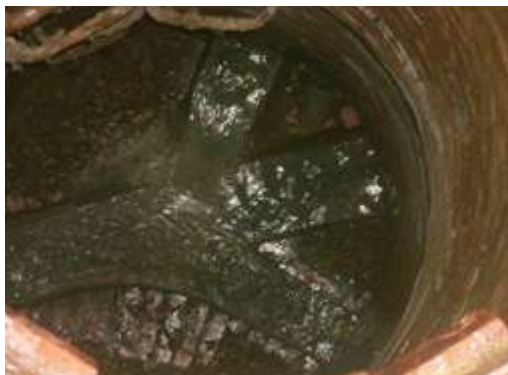
Defect 3

Steps Count: **7** Missing: **2** ☒ **Corroded**

Surcharge ☒ **Evidence Of Surcharge** Depth: **4** (ft.) ☐ Active Surcharge Present

SURCHARGE EVIDENCE AND
CORRODED STEPS

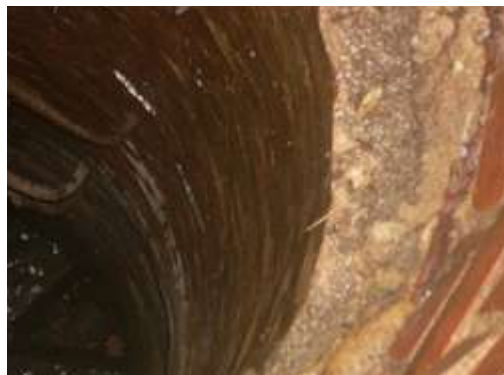
Defect 4

MISSING STEPS

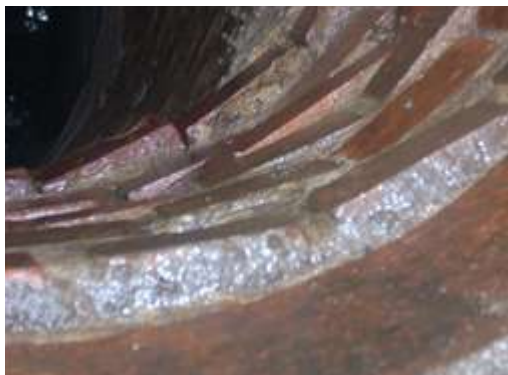
Defect 1

Frame Offset: **1** (in.) Condition: ☒ Sound ☐ Cracked ☐ Leaks

FRAME OFFSET

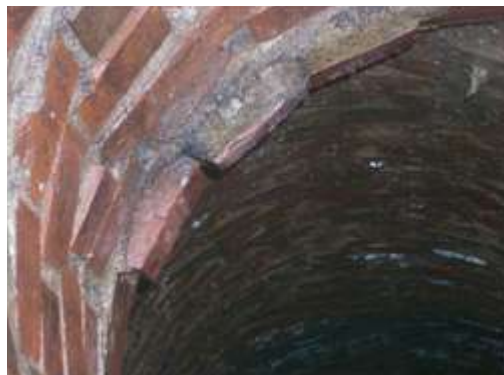
Defect 2

Condition: ☐ Sound ☐ Cracked ☐ Root Intrusion ☒ **Loose Brick** ☐ Deteriorated

LOOSE CHIMNEY BRICKS

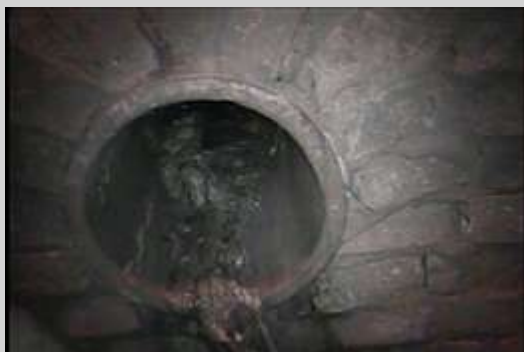
8 O'Clock Inflow

Deposits: ☐ None ☐ Mud ☒ **Sludgy** ☐ Debris ☐ Grease

Silt Depth: **5** (in.) Deposits Extent: **Medium**

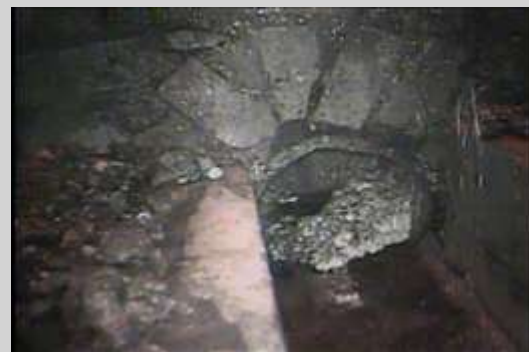
Drop In @ 8 O'Clock

Drop: **Outside** Rod and Bar
Angled: **Yes** Reading: **14.59** (ft.)
Inv Depth: **15.59** (ft.)

Drop Condition: **Partly Clogged**
